Manhole Inspection Summary

Manhole # S61EE_009MH

Insp Date: **3/2/10 4:58 PM**

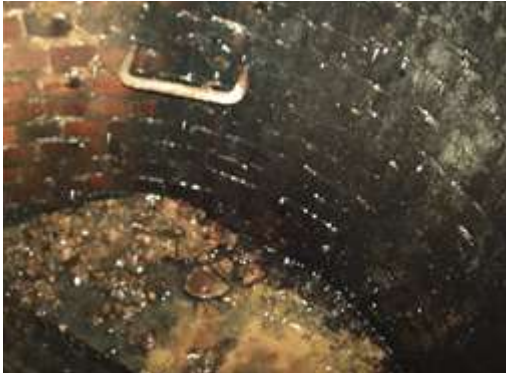
Defect 5

debris

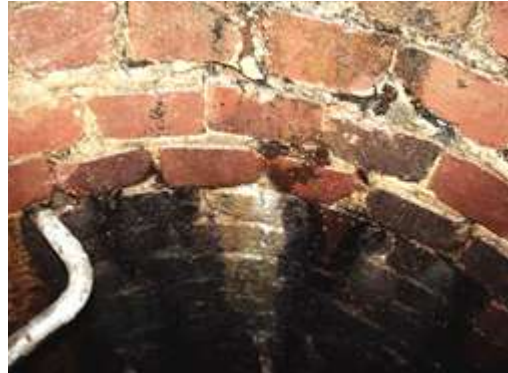
Defect 4

loose bricks

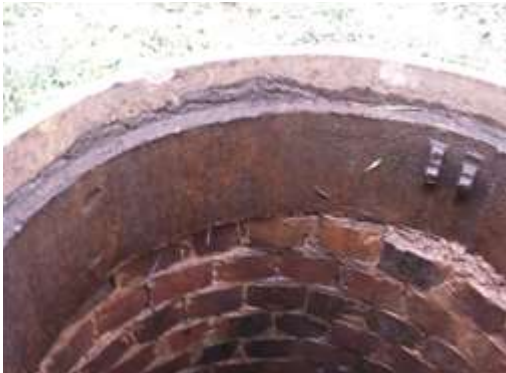
Defect 3

☒ **Leaks**

frame leaks

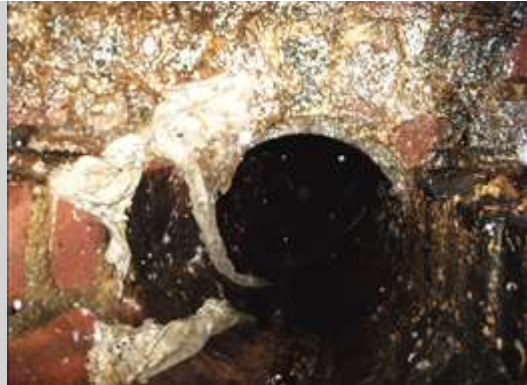
12 O'Clock Outflow

Pipe Height: **14.4** (in.) Rod and Bar (Angled)
Pipe Material: **Clay** ☐ Pipe Lined
Invert Depth: **29.92** (ft.) Flow Characteristics: **Slow**
Deposits: ☒ None ☐ Mud ☐ Sludge ☐ Debris ☐ Grease
Silt Depth: (in.) Deposits Extent:
Infiltration: **None** Pipe Seal Cond: **Sound**

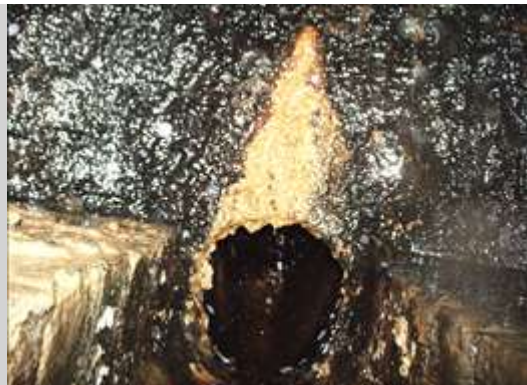
6 O'Clock Inflow

Pipe Height: **13.2** (in.) Rod and Bar (Angled)
Pipe Material: **Clay** ☐ Pipe Lined
Invert Depth: **9.08** (ft.) Flow Characteristics: **Slow**
Deposits: ☒ None ☐ Mud ☐ Sludge ☐ Debris ☐ Grease
Silt Depth: (in.) Deposits Extent:
Infiltration: **None** Pipe Seal Cond: **Sound**

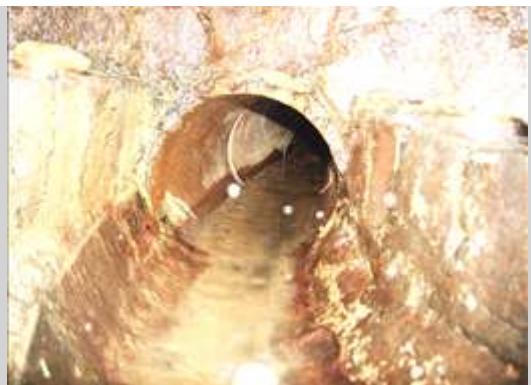
9 O'Clock Inflow

Pipe Height: **12** (in.) Rod and Bar (Angled)

Infiltration: **None**

Pipe Seal Cond: **Sound**
